Walkability Audit

15th January, 2016

St Oliver's National School

**Ballylongford
Co. Kerry**

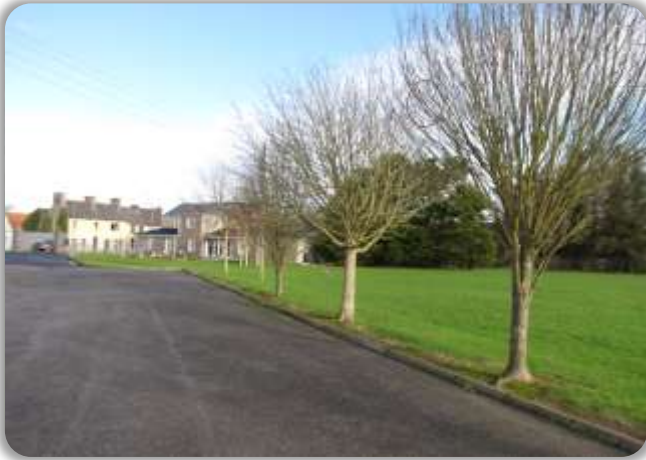
We have a lovely school grounds - lovely playground/field area/trees/birds/grass.

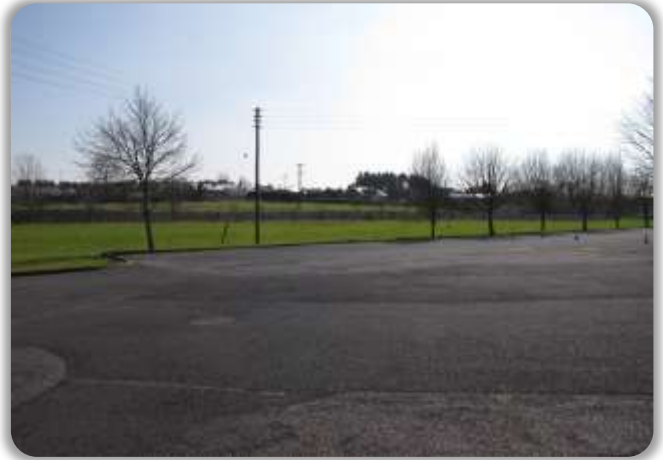
We have a wall/fence around the Church car park and our school.

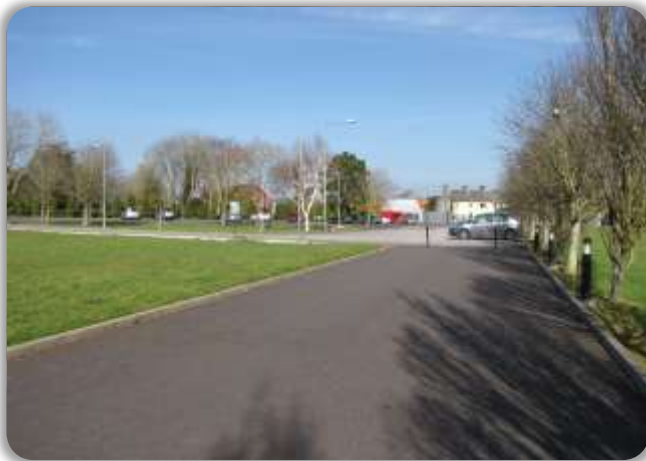
We have a wide drive to our school building entrance.

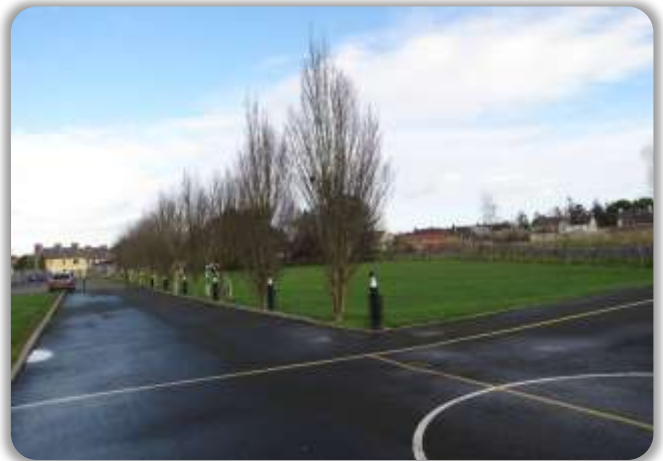
We have lighting to the left of the drive into our school.

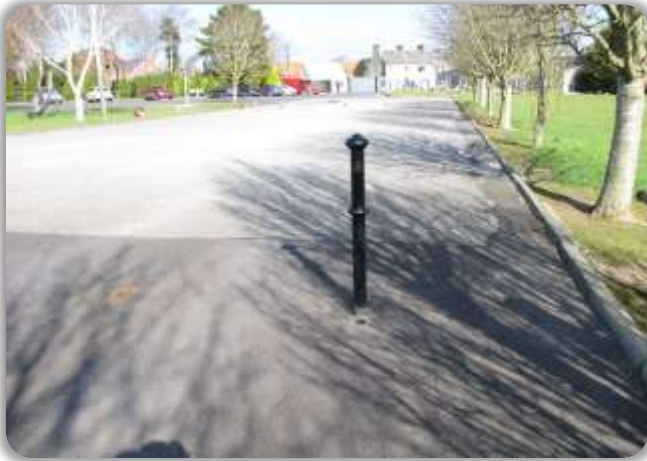
We have bollards at the end of the school drive.

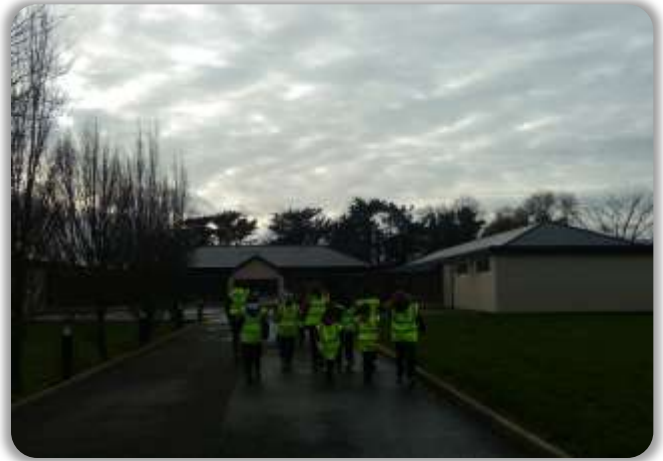
No cars come onto the school grounds.

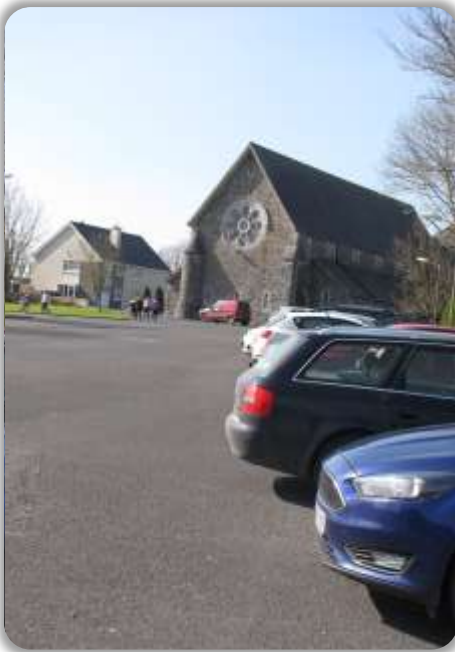
Cars park in Church car park.

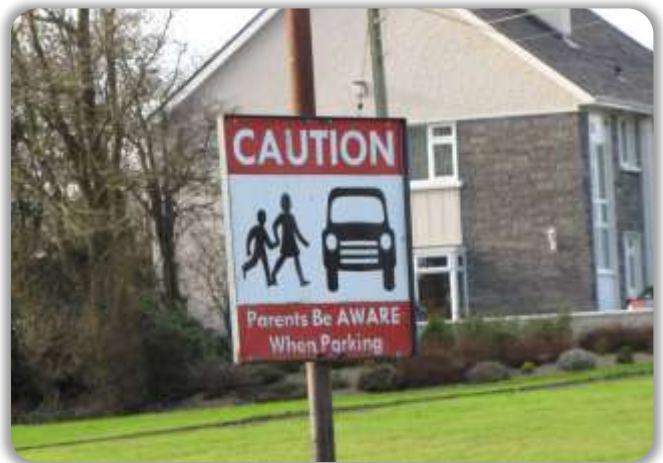
There is a road sign on the Church car park – caution.
This is much needed.

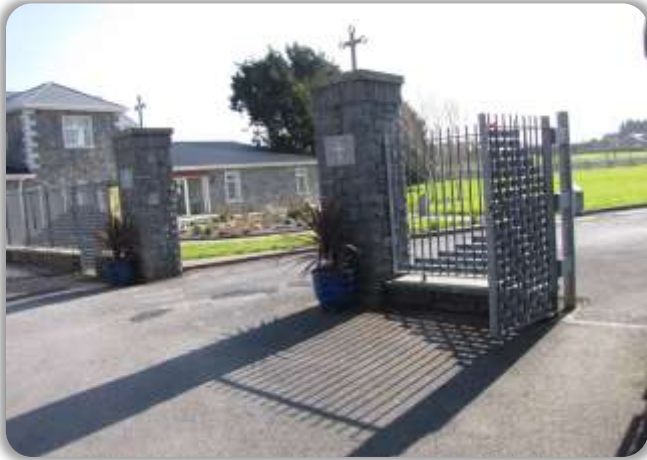
The pedestrian entrance and car entrance is separate into Church car park

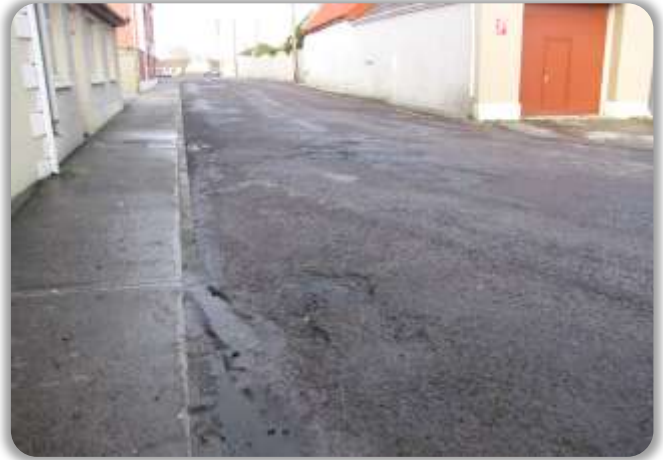
We do have a footpath on one side of the road from the school to the park and stride location

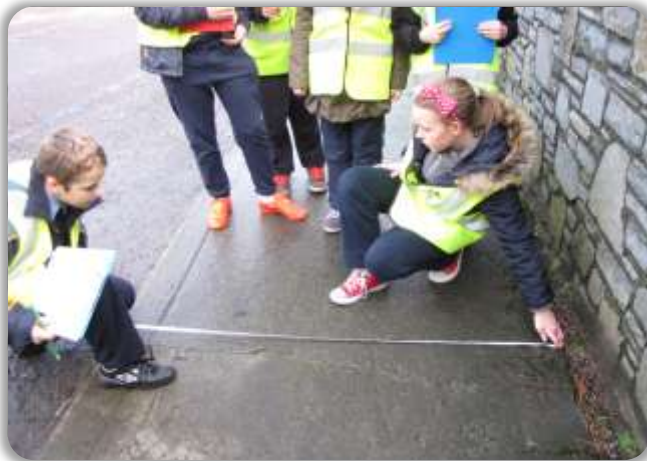
The footpath is a good width

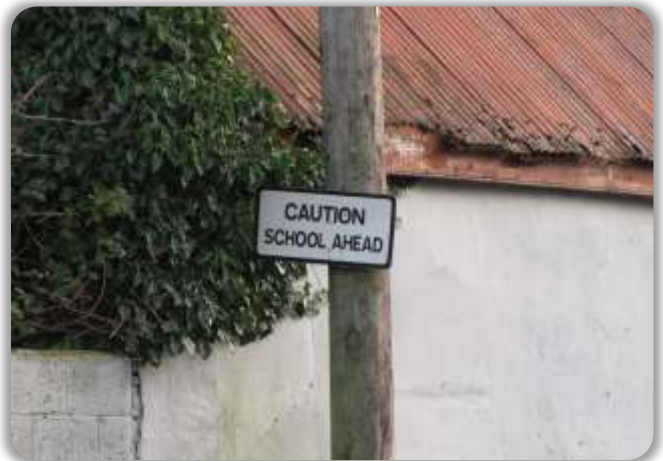
In one direction there is a small white road sign high up – 'Caution School Ahead'

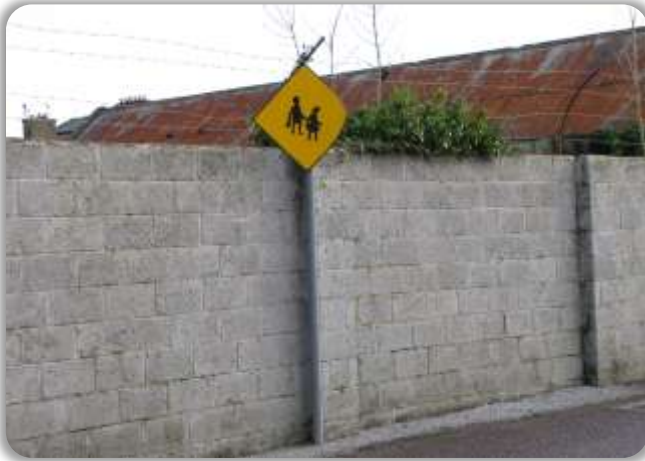
There is a school ahead road sign but it is twisted.

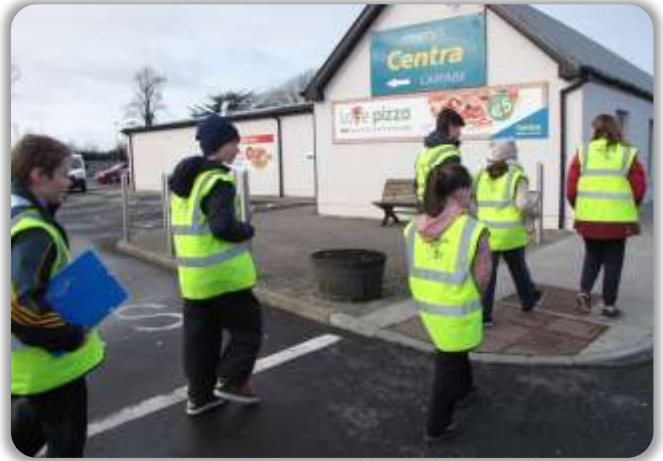
There are parking spaces in the back of the local Centra shop – road signs and markings are in place by the entrance/exit to the car park area.

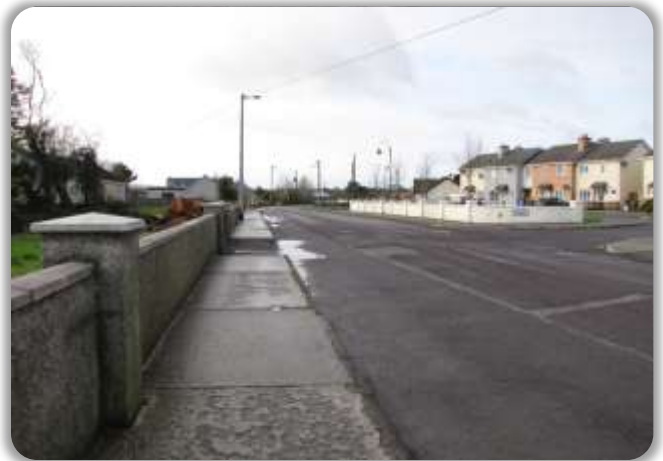
Street lights are in place through the village.

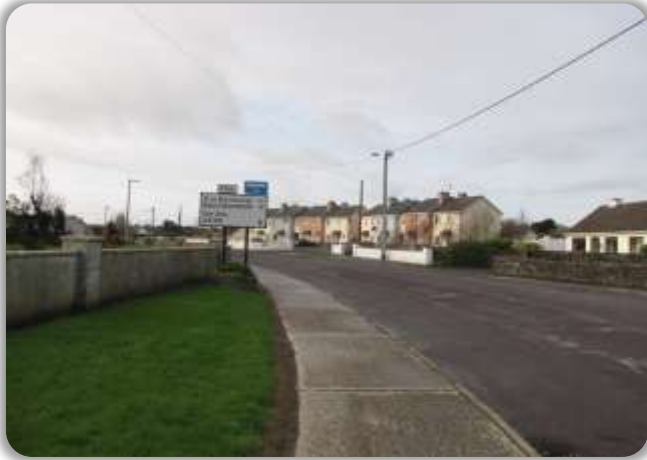
The footpaths on Sand Quay are in good condition.

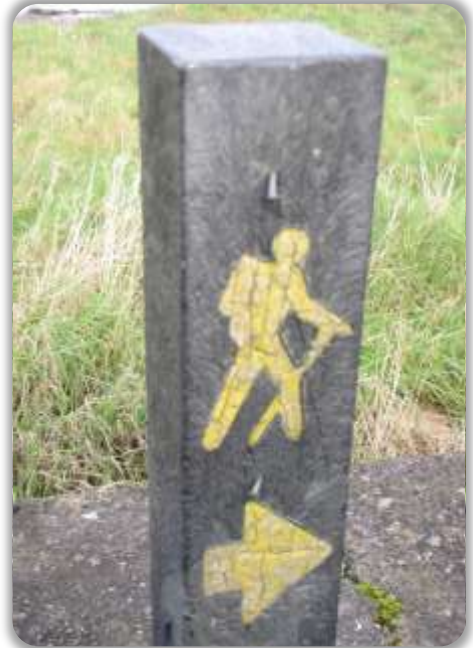
We saw signs for walking routes on our walk.

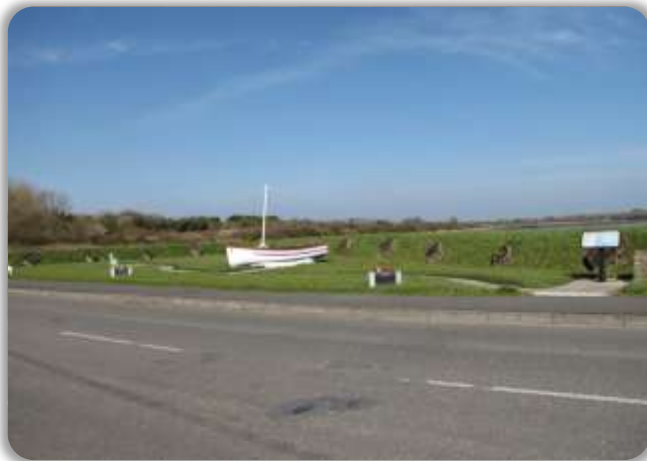
We saw some lovely work by the Tidy Towns throughout the village.

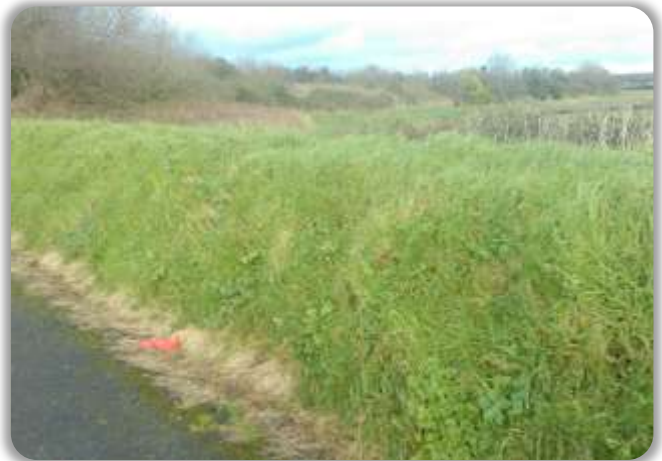
There is a high raised grass area by river – helps if flooding.

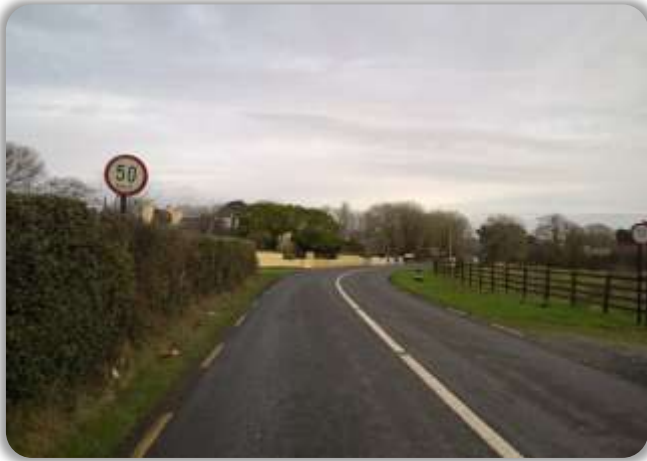
The speed through the village is 50km/h – road signs are in place

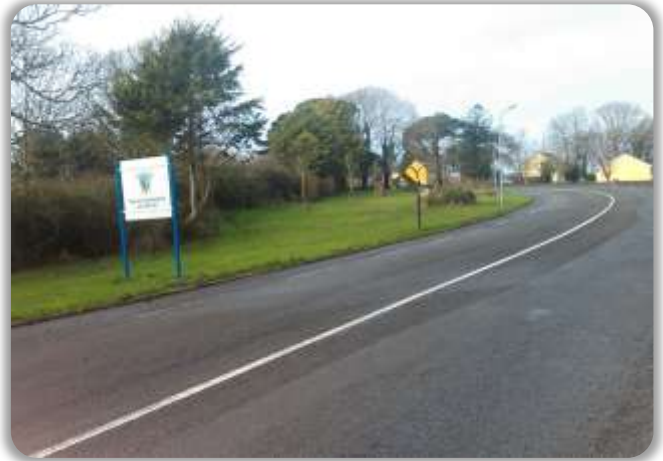
The road surface on the R551 from around the L6010 junction towards Asdee improves greatly and is very smooth

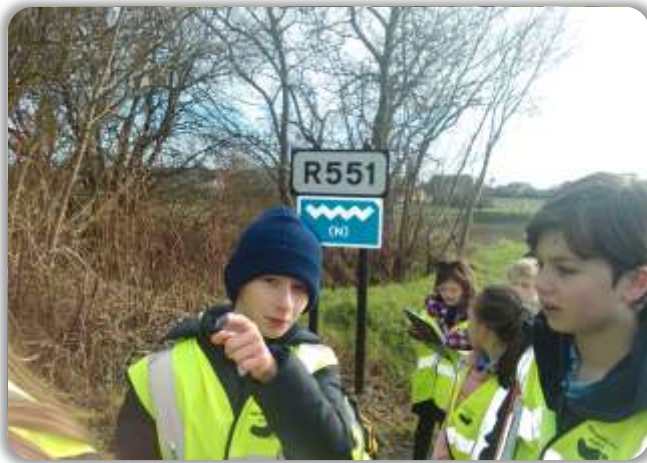
Road signs for the road number, Wild Atlantic Way and for Asdee, Ballybunion etc are in place

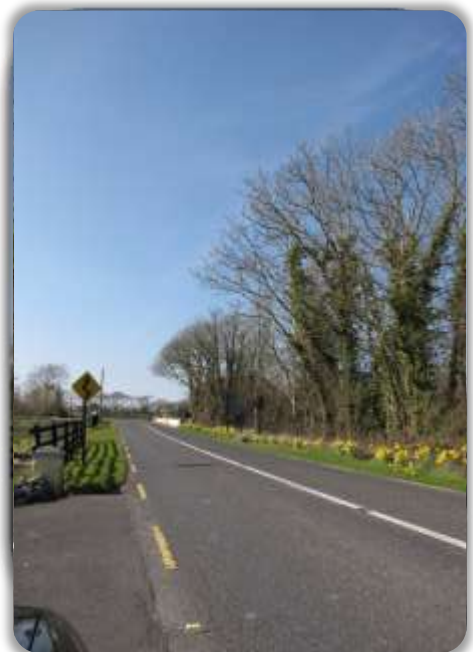
We look after our village. We found no litter on route

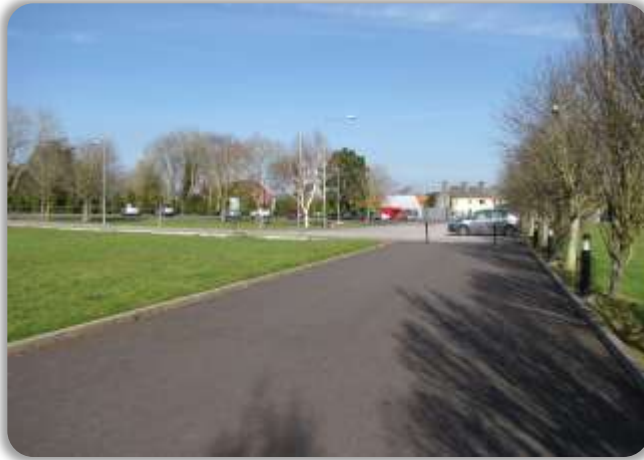
You have to go through the Church car park to get to our school. Raise awareness on road safety in school.

The Church car park does get busy during mass time, for weddings, funerals etc.

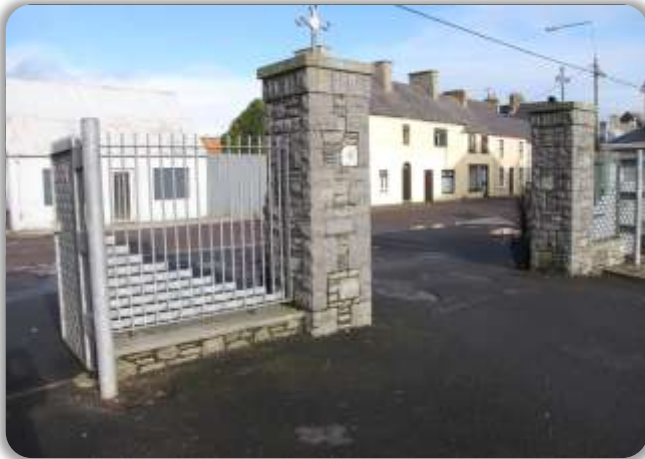
The entrance to the Church car park is very narrow and only one car/vehicle can use it at a time. This causes issues with traffic entering and existing the car park.

3. The entrance to the Church car park is very narrow and only one car/vehicle can use it at a time. This causes issues with traffic entering and existing the car park. Can anything be put in place to help with this? Ask Kerry County Council.

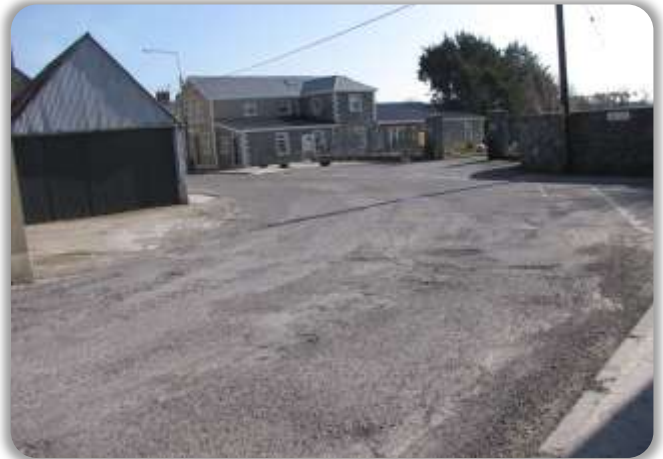
The pedestrian entrance is right next to the car entrance so you have to be careful as this area is busy before and after school.

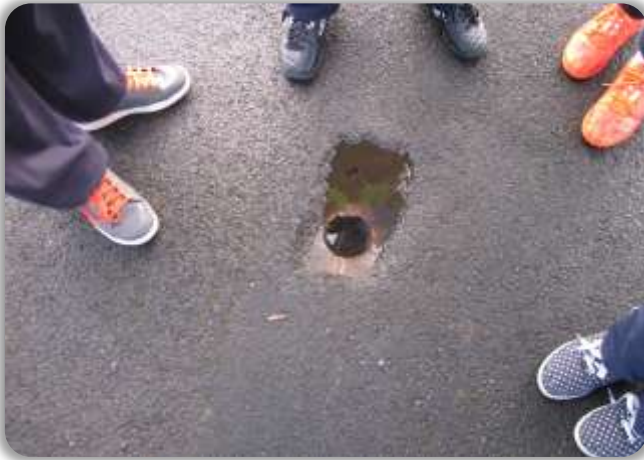
The middle bollard at the end of the school drive is sometimes removed (for deliveries etc) so be careful walking past the hole in the ground .

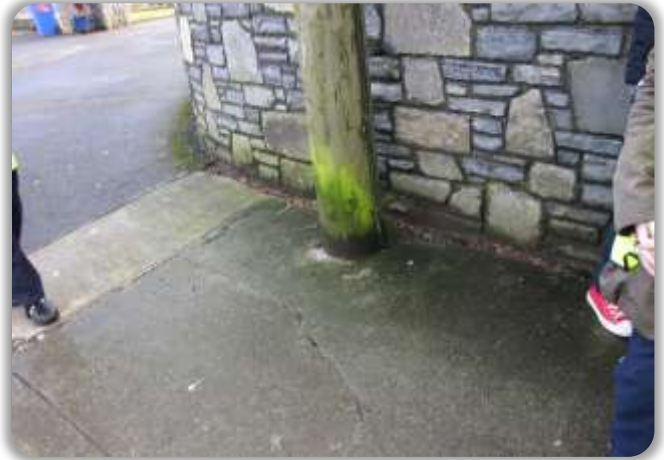
ESB poles are outside the entrance so watch out for these.

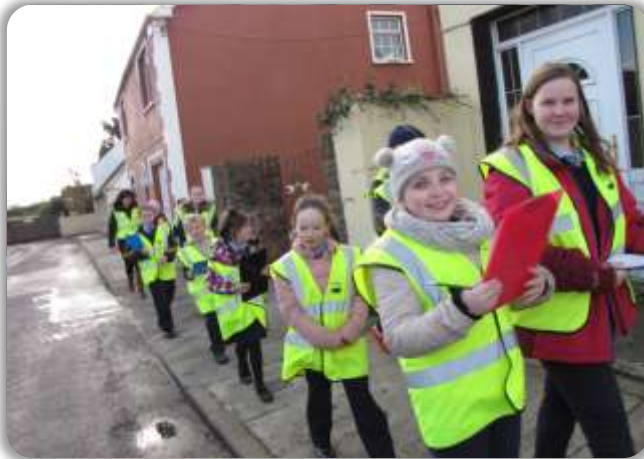
There is only one continued footpath through the village. The footpath on the opposite side of the road stops and starts.

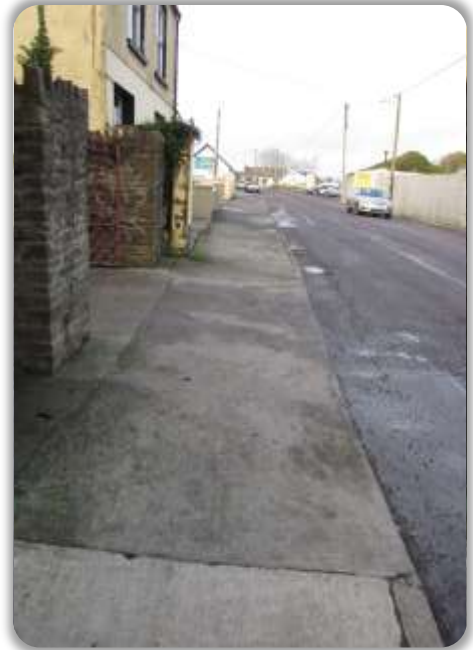
The footpath from our school is in very poor condition.

8. The footpath from our school is in very poor condition so ask KCC to look at this.
9. You need to watch out for the leaves on the footpath.
10. The road surface through the village is in very poor condition so ask KCC to resurface the road.

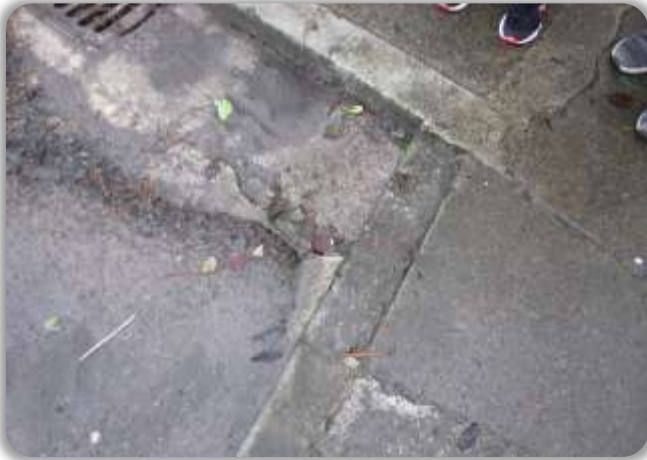
You need to watch out for the leaves on the footpath.

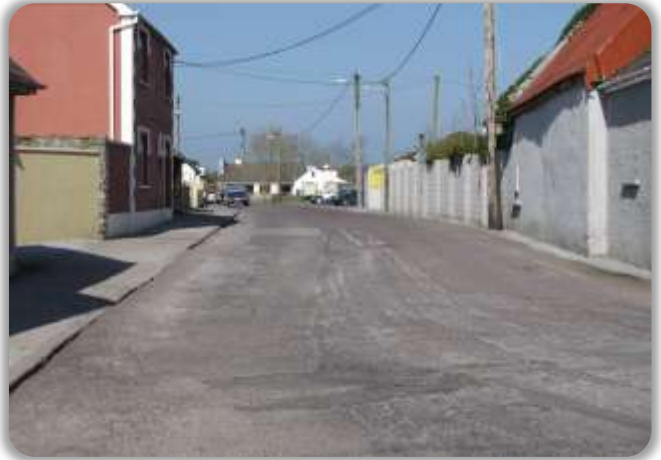
The road surface through the village is in very poor condition. Ask KCC to resurface the road.

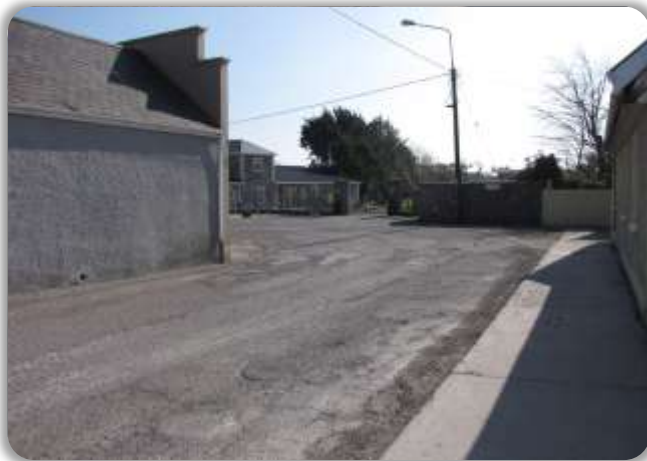
Our school entrance is located on a bend – opposite the fire station. This is why we need road markings and signs to indicate a school ahead. Ask KCC to add these.

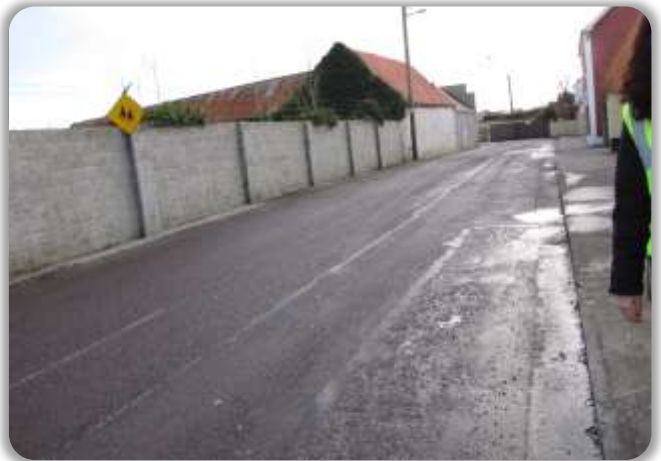
There are no road markings either direction to indicate a school ahead on the R551 through the village. Asks KCC to add these.

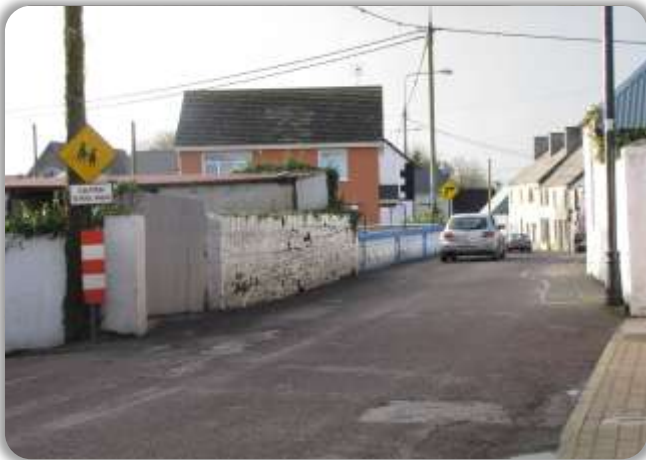
There is no footpath over the bridge just pass our school so be careful walking here.

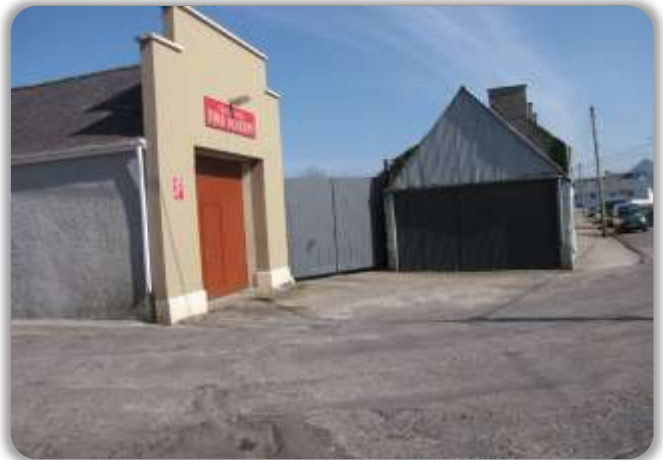
The double yellow road markings outside the fire station need to be repainted. Ask KCC.

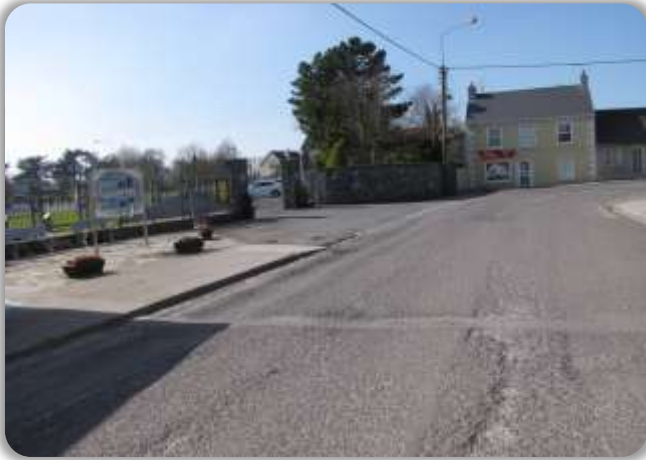
There are no road markings on the R551 throughout the village. Ask KCC about this.

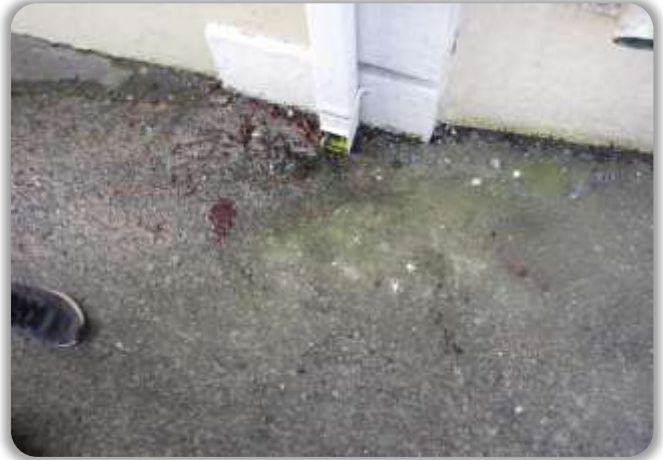
There are some down pipe/gutter running down some houses straight on the footpath – water from them goes straight onto the footpath so it can be slippery if it is raining, frost etc. Watch out for these.

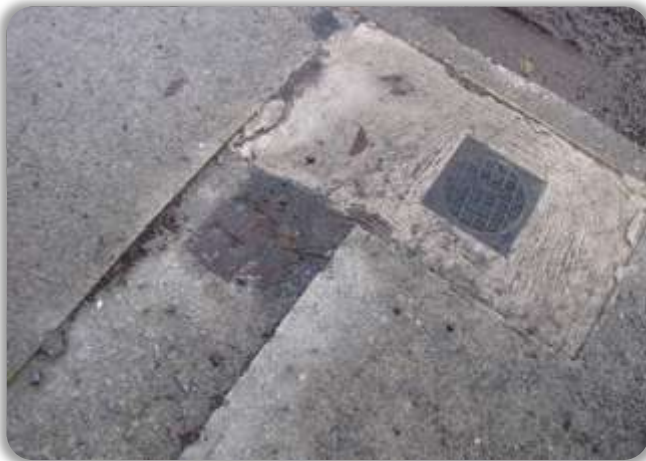
There are drain covers on the footpath on route – if they get wet they are slippery. Just watch out for these.

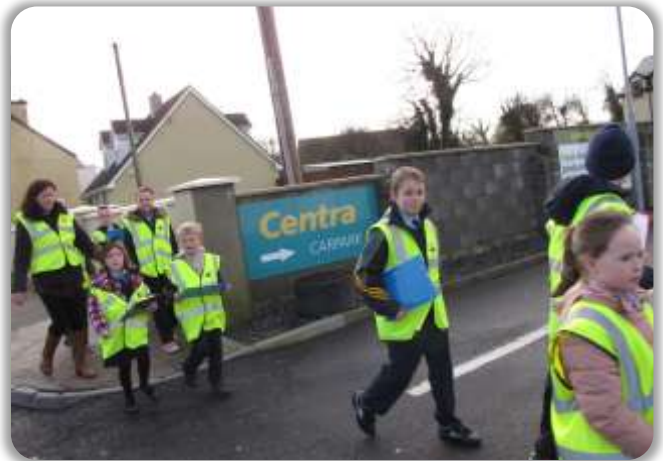
You need to watch out for entrances to homes and businesses if out walking or cycling. Raise awareness in school.

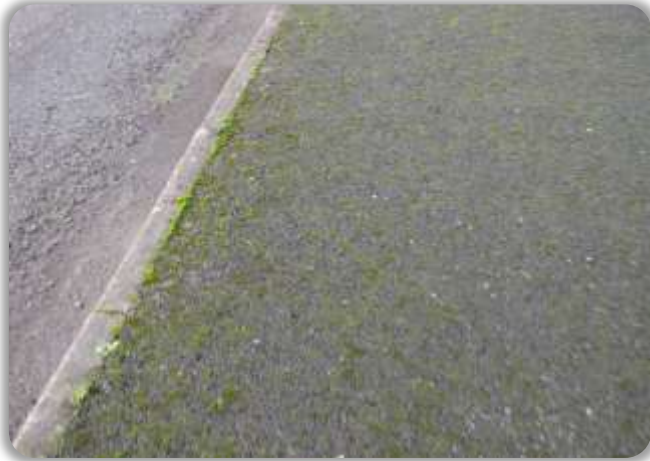
Moss is in place on the footpath so be careful walking. Could it be removed/cleaned?

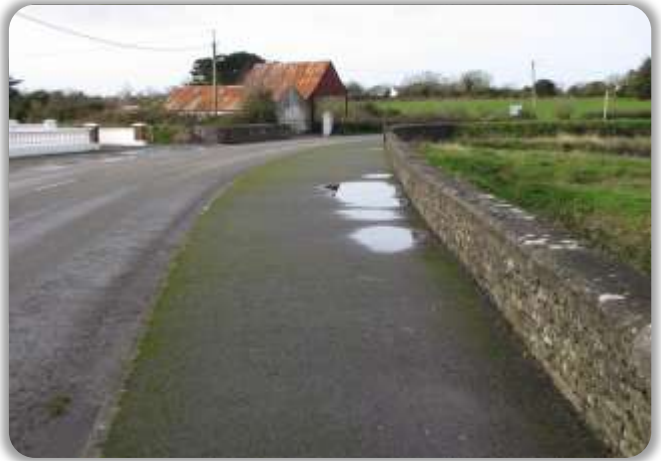
Puddles of water collect on the footpath by the Tidy Towns work – Sand Quay so watch out for this.

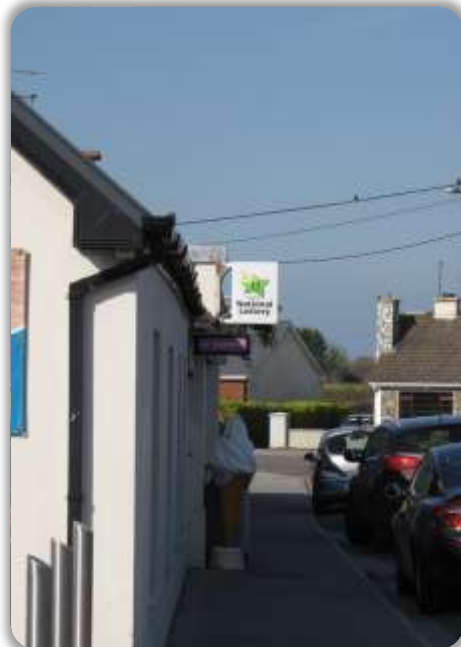
You need to watch out for the bin situated outside Centra as you could bang into it. Raise awareness in school.

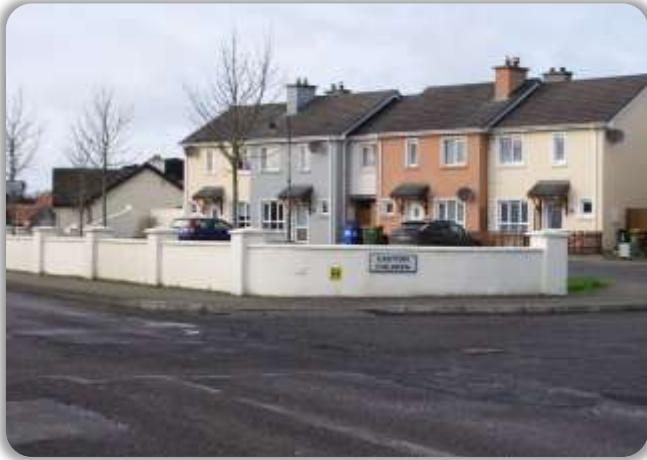
You need to watch out for the entrance and exit to the housing area on Sand Quay 'Radharc na habhann estate). Raise awareness in school and in the community.

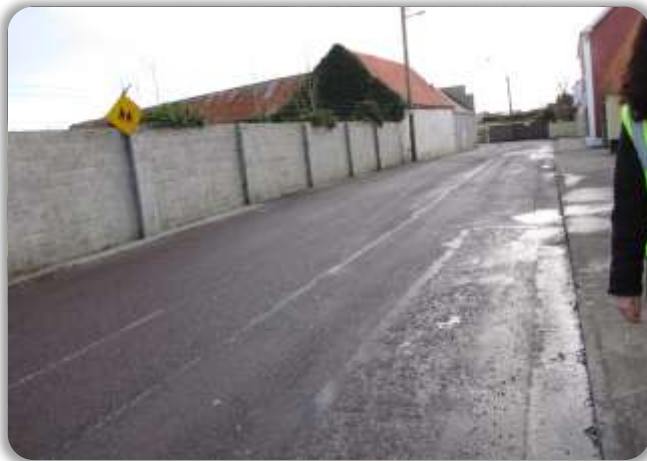
The road R551 up to L6010 junction is in good condition but then is in poor condition from there through the village. Could the road be resurfaced through the village, road markings added etc. Ask KCC.
