Walkability Audit

15th January, 2016

St Oliver's National School

**Ballylongford
Co. Kerry**

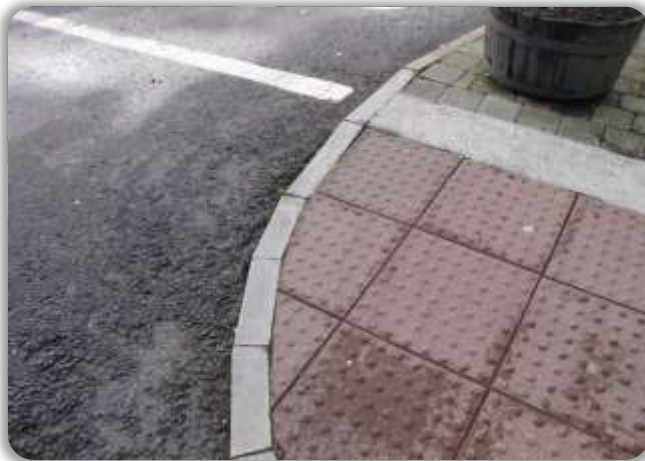
There are parking spaces in the back of the local Centra shop – road signs and markings are in place by the entrance/exit to the car park area.

Good to have these in place.
